Macedon Gas Project

Compliance Assessment Report

**Macedon Gas Development
Pipeline Rehabilitation Monitoring
July 2014**

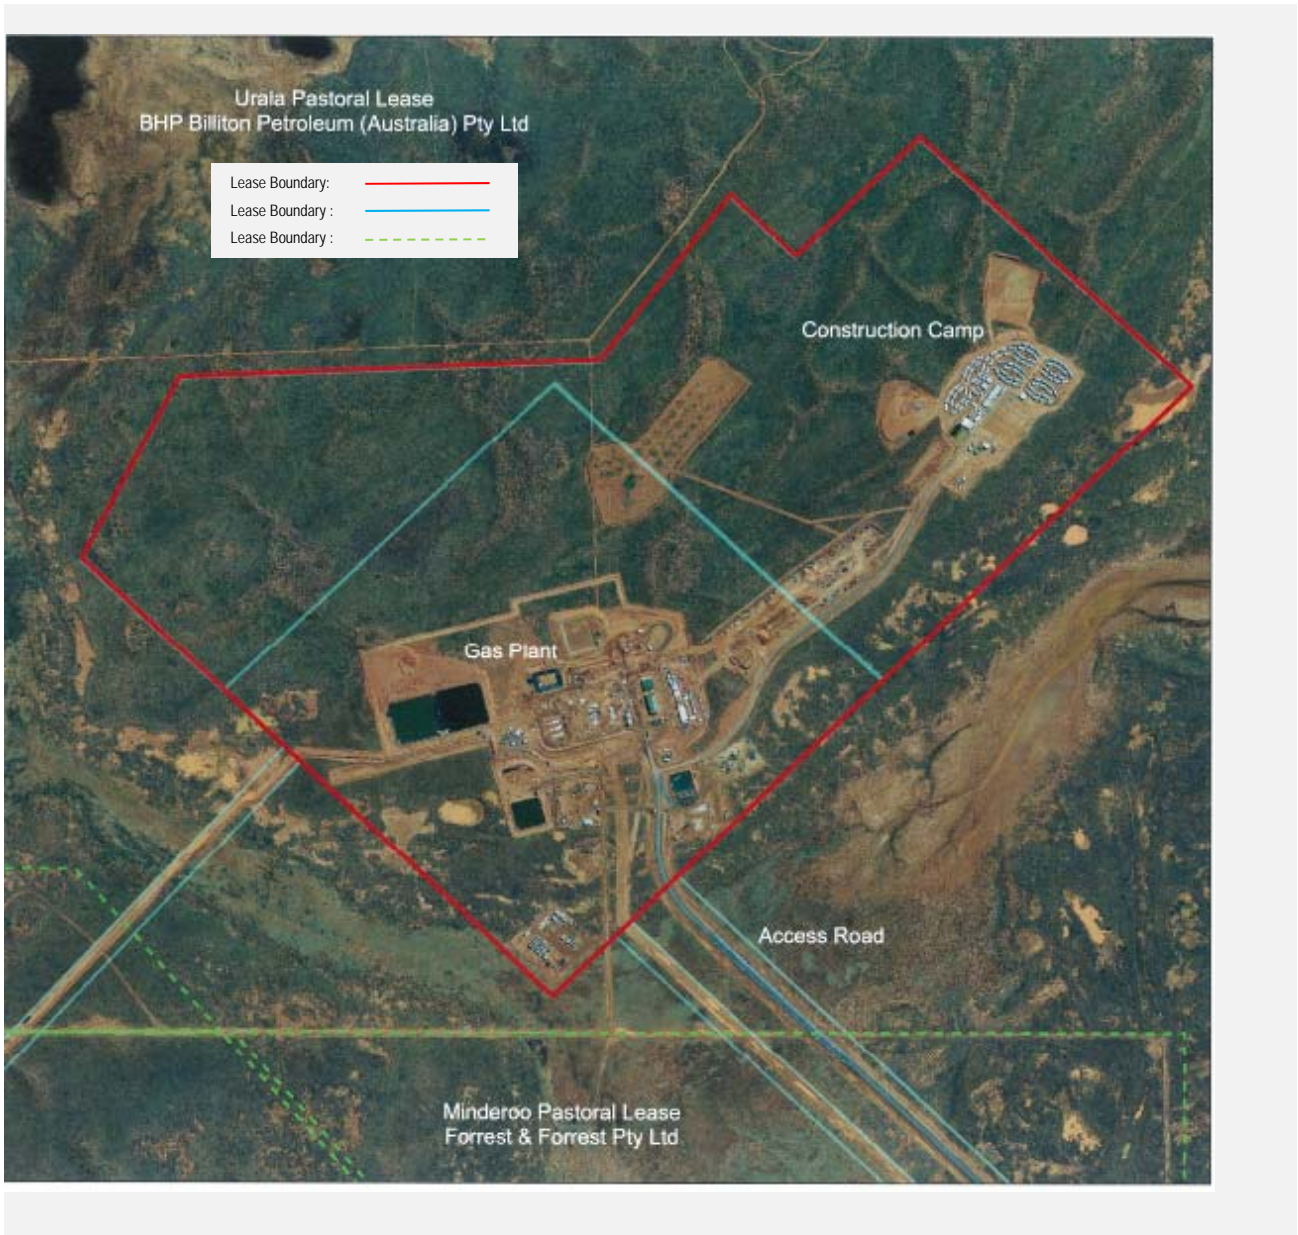
Figure 2 Macedon Gas Plant Lease and Layout

The Macedon Gas Plant Lease area for the gas processing facility and associated infrastructure, including the ground flares and evaporation pond, construction lay down areas and construction accommodation areas is shown in Figure 2.

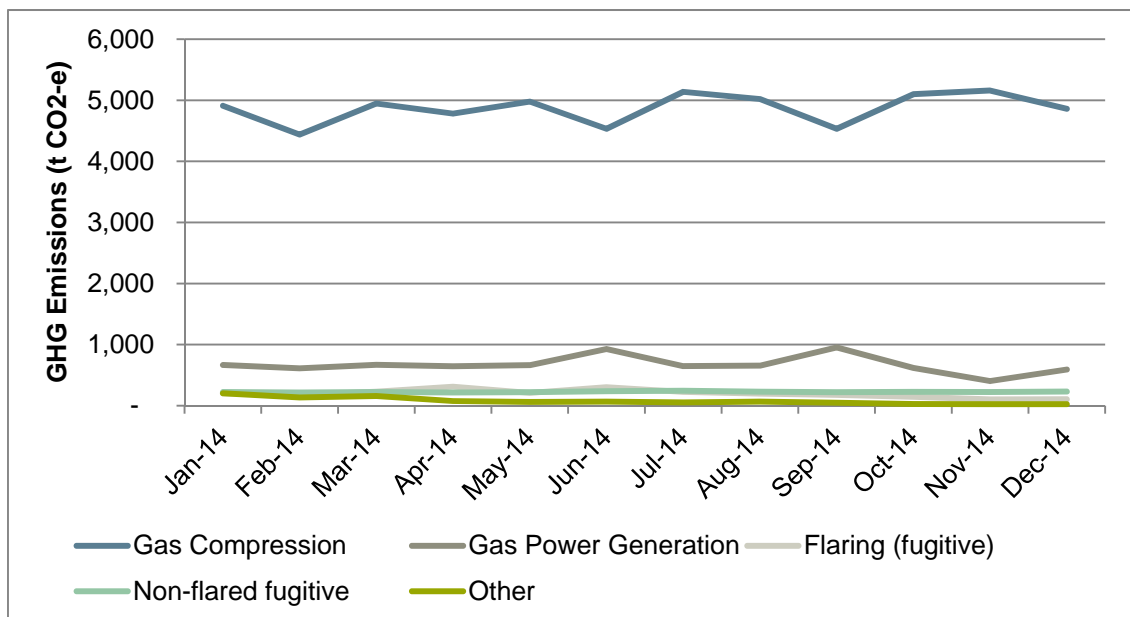
Figure 3: Macedon Gas Project GHG Emissions (1 January 2014-31 December 2014)

Macedon Gas Project GHG emissions for the period 1 Jan 2014 to 30 December 2014 are illustrated in Figure 3 and Table 1.

Annual GHG emissions for the period 1 Jan 2014 to 30 December were 72,430 tonne equivalent of carbon dioxide (CO₂-e); carbon emissions intensity for the period was 8 t CO₂-e per 1000 barrels of oil equivalent production. Recorded emissions are lower than emissions predicted for 2014 in the Final EPS (85,000 t CO₂-e); variance between predicted and actual emissions is due to higher production rates used to estimate carbon emissions in the EPS when compared to current operations.

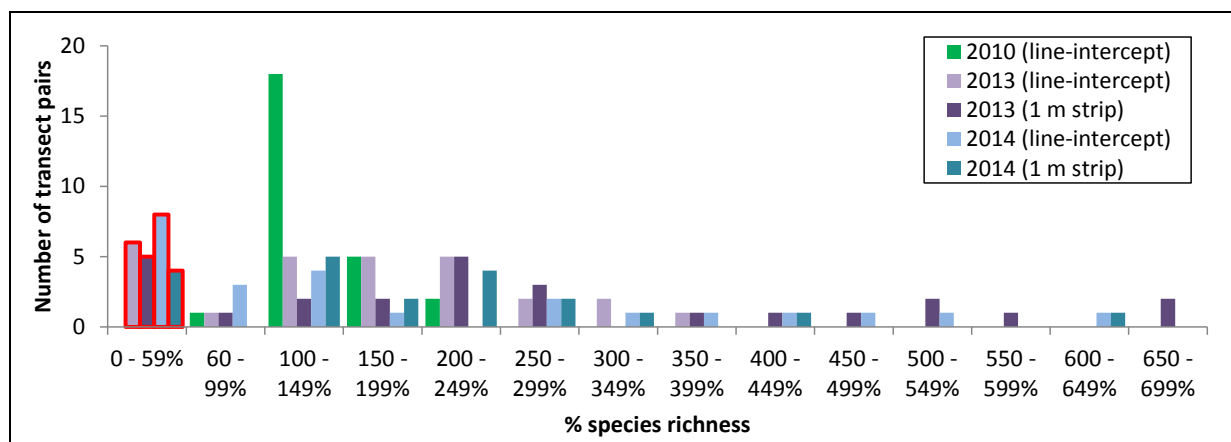
The observed increase in the number of species in rehabilitated 1 m wide strip transects between 2013 and 2014 was likely due to idiosyncratic germination of some annual species (e.g. *Trachymene pilbarensis*, *Trichodesma zeylanicum* and *Nicotiana* spp.) and slow germination/colonisation of at least some additional perennial species (e.g. *Ptilotus* spp., *Scaevola parviflora* and *Sida cardiophylla*).

Figure 4: Percentage difference in species richness in rehabilitated transects compared with species richness in paired analogue transects. Red borders indicate that the 60% species richness rehabilitation target has not yet been met.

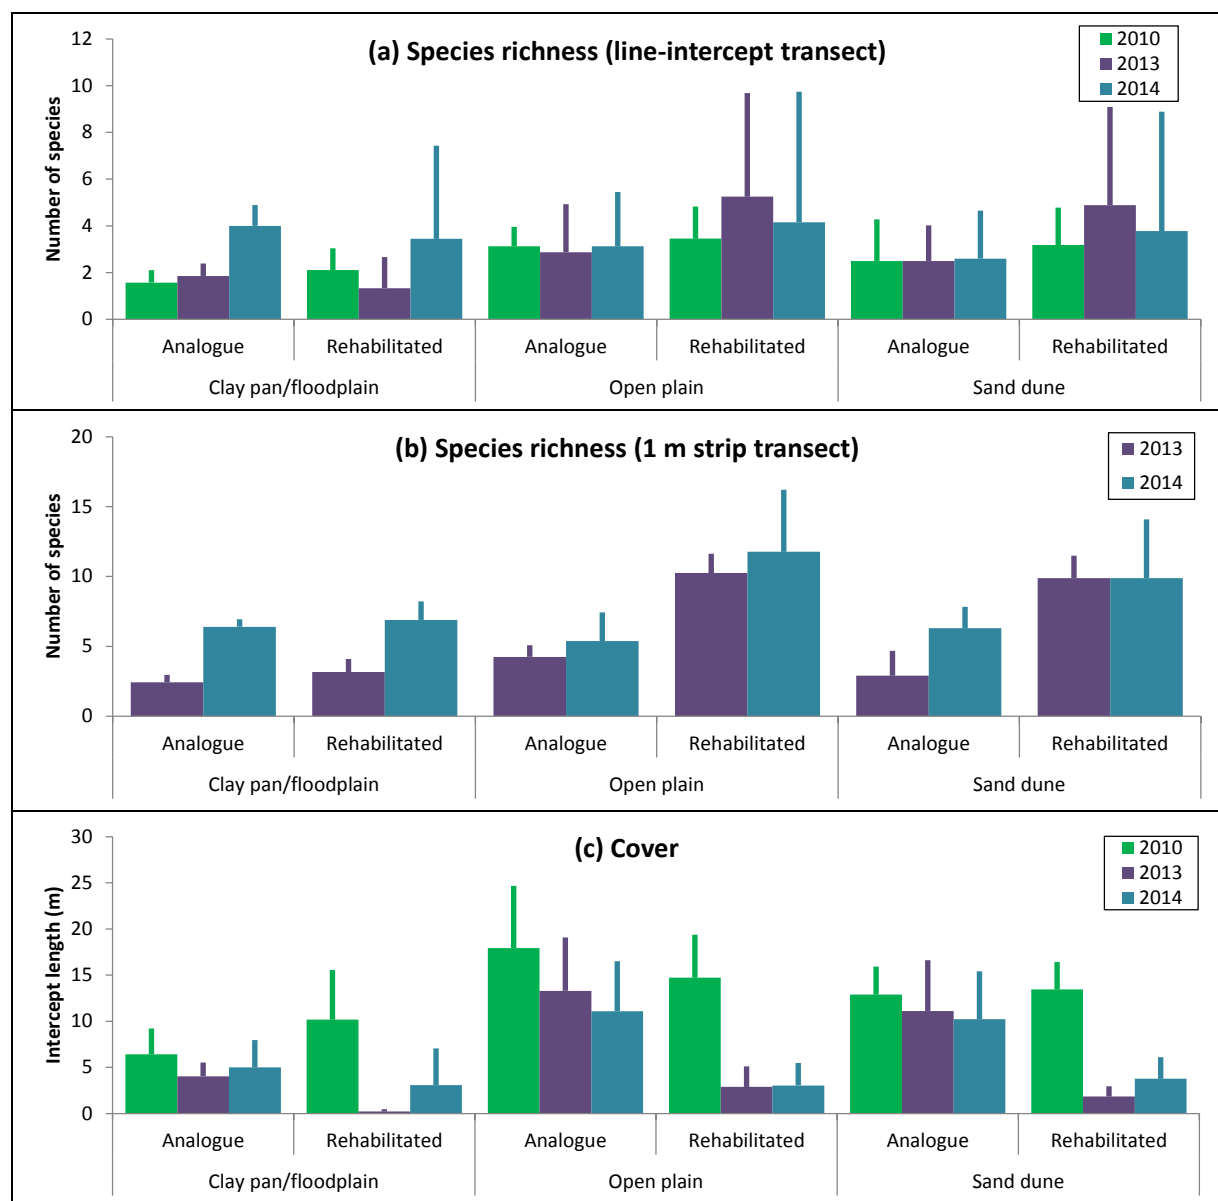
When changes in species richness were compared between different habitats, there were no clear differences between habitats (Figures 5a and 5b). Also, the mean species richness did not change greatly between years (except for clay pan/floodplain habitat: Figure 5a). However, in rehabilitated transects, error bars (= standard deviation (SD)) were larger in 2013 and 2014 compared with 2010. Therefore, there was much larger spatial variation in species richness after the disturbance and rehabilitation.

decrease in both rehabilitated and analogue transects (Figure 5c). The decrease was much greater in rehabilitated transects than in analogue transects. The disturbance and rehabilitation resulted in almost no cover of native vegetation in clay pan/floodplain habitat in 2013. However, at least some cover of native vegetation had returned to those transects in 2014.

Figures 5: Changes in species richness in line-intercept length (a), in 1 m strip transects (b), and the length of transects intercepted by native species in different habitats (c). Mean + SD.

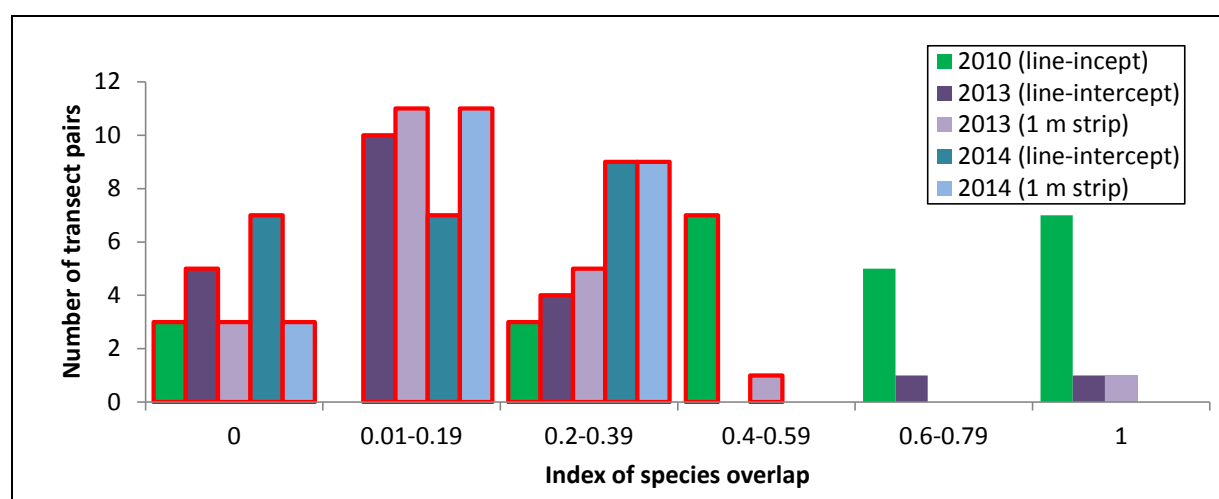
In 2010, all species shared between the paired transects were perennials. With disturbance, the perennial species were lost temporarily from the rehabilitated transects. However, some perennial species such as *Triodia* spp. and *Acacia* spp. have already returned to the rehabilitated transects by 2013. In addition to perennials, some annuals such as *Amaranthus undulatus*, *Portulaca oleracea*, *Nicotiana rosulata* and *Gomphrena canescens* have been shared between the paired transects in 2013 and 2014.

Figure 6: Comparisons of species composition between paired rehabilitated and analogue transects. The number of transects that showed less than 0.6 (60%) overlap in shared species are indicated by red borders.

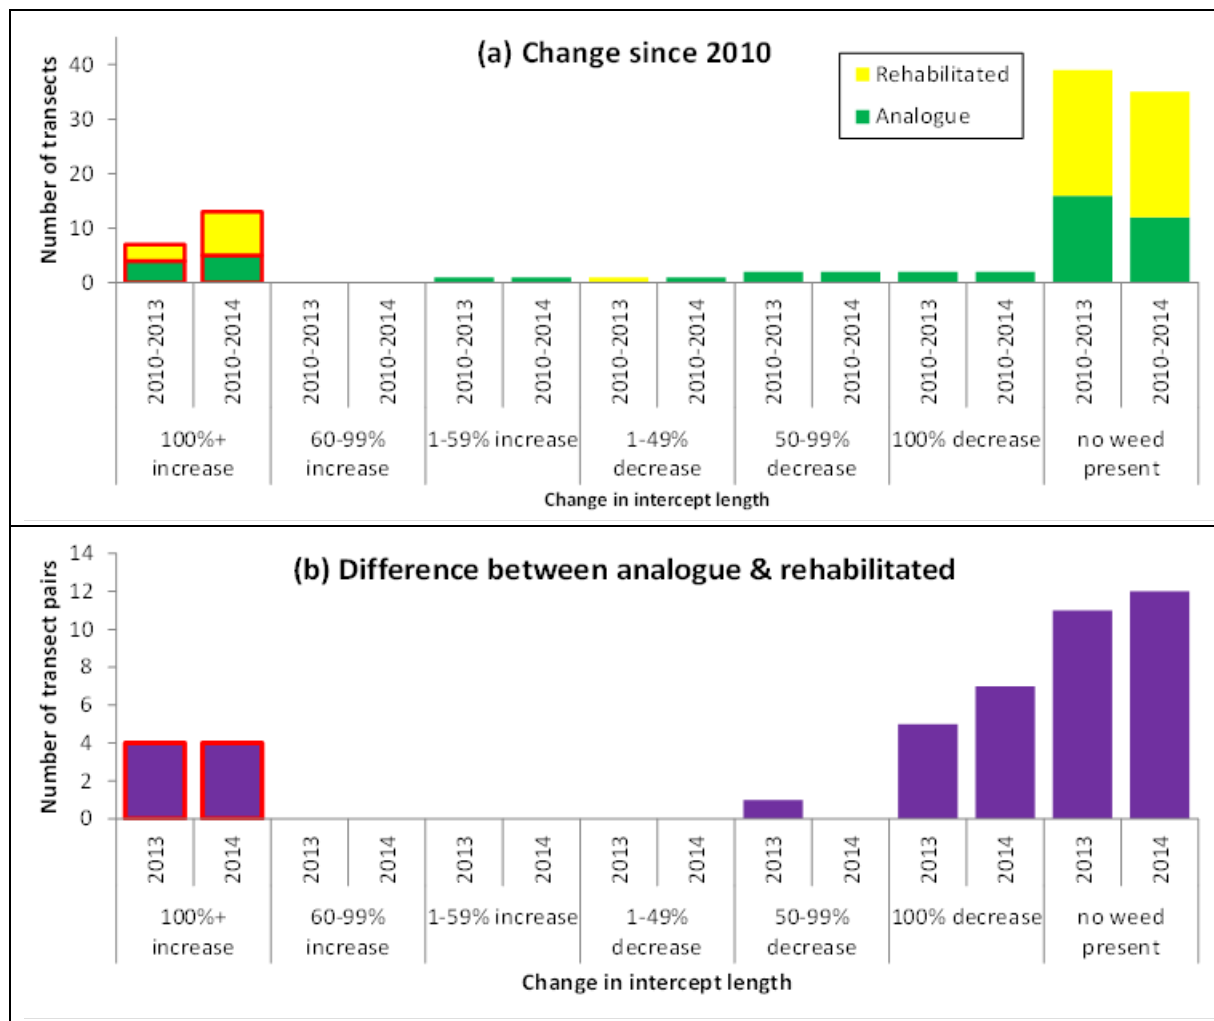
Figures 7: Comparison of changes in the intercepted length by weed species since 2010 (a) and differences between analogue and rehabilitated transects (b). The number of transects that showed a 100% or greater increase in the intercepted length are indicated by red borders.

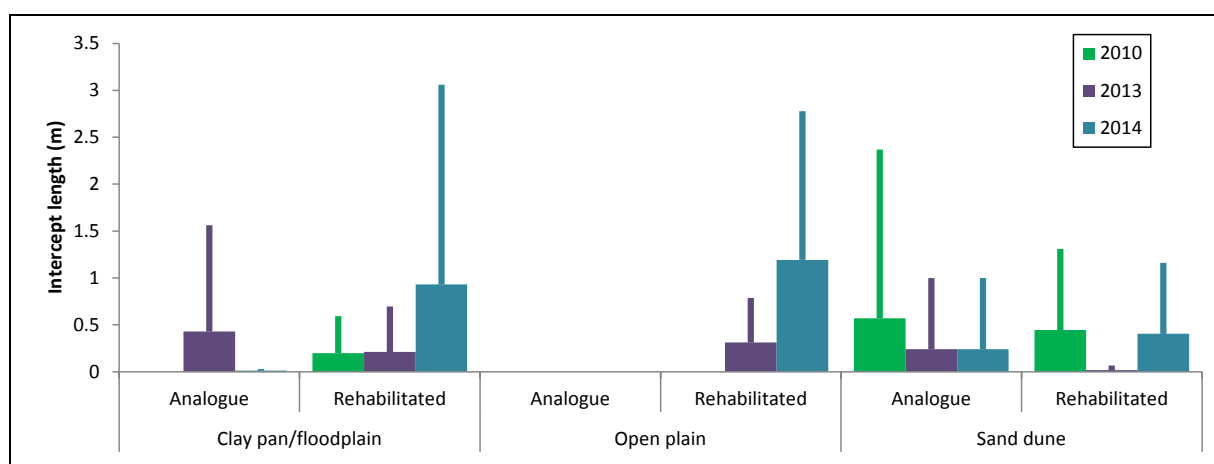
Figure 8: Changes in the length of transects intercepted by weeds in different habitats. Mean + SD.
