Document Title: Scarborough Execute Environmental Monitoring Program: Dredging and Spoil Disposal Water Quality Monitoring Report

Dredging and Spoil Disposal Water Quality Monitoring Report

Scarborough Execute Environmental
Monitoring Program

REPORT NUMBER: SA0006RH0000003

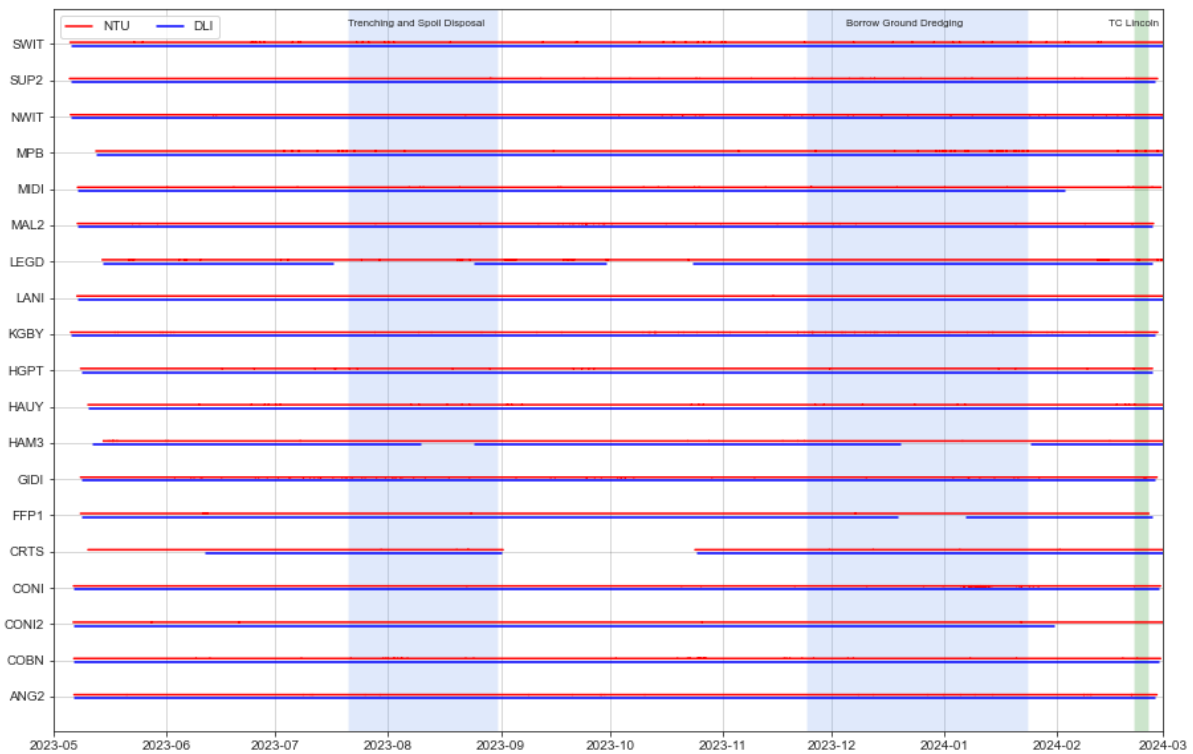
Figure 6: Data capture at each water quality monitoring site

The water quality monitoring systems were installed between 5 and 14 May 2023, and retrieved between 27 February and 6 March 2024, equating to approximately 10 months of water quality

monitoring data (Figure 6). The deployment of the monitoring systems was in accordance with the timing requirements in Section 11.2.2 of the DSDMP. Throughout this period, the water quality monitoring systems had five scheduled maintenance visits (excluding installation and retrieval trips) however, when no data was transmitted or recorded by a logger or specific issues were encountered at certain sites, reactive maintenance trips were required to investigate, troubleshoot and rectify monitoring systems. A total of four reactive trips occurred in June, July and November 2023 and January 2024. Details of the installation scheduled and reactive maintenance trips and retrieval dates for each water quality monitoring site is provided in Appendix A.

¹ To simplify the naming convention, the second dredging and disposal period (as seen in Figure 6 and various other figures) has been labelled as ‘Borrow Ground Dredging’ however, it represents seabed disturbances from trenching along the trunkline route in Commonwealth waters as well as offshore borrow ground dredging and backfill activities along the trunkline route.

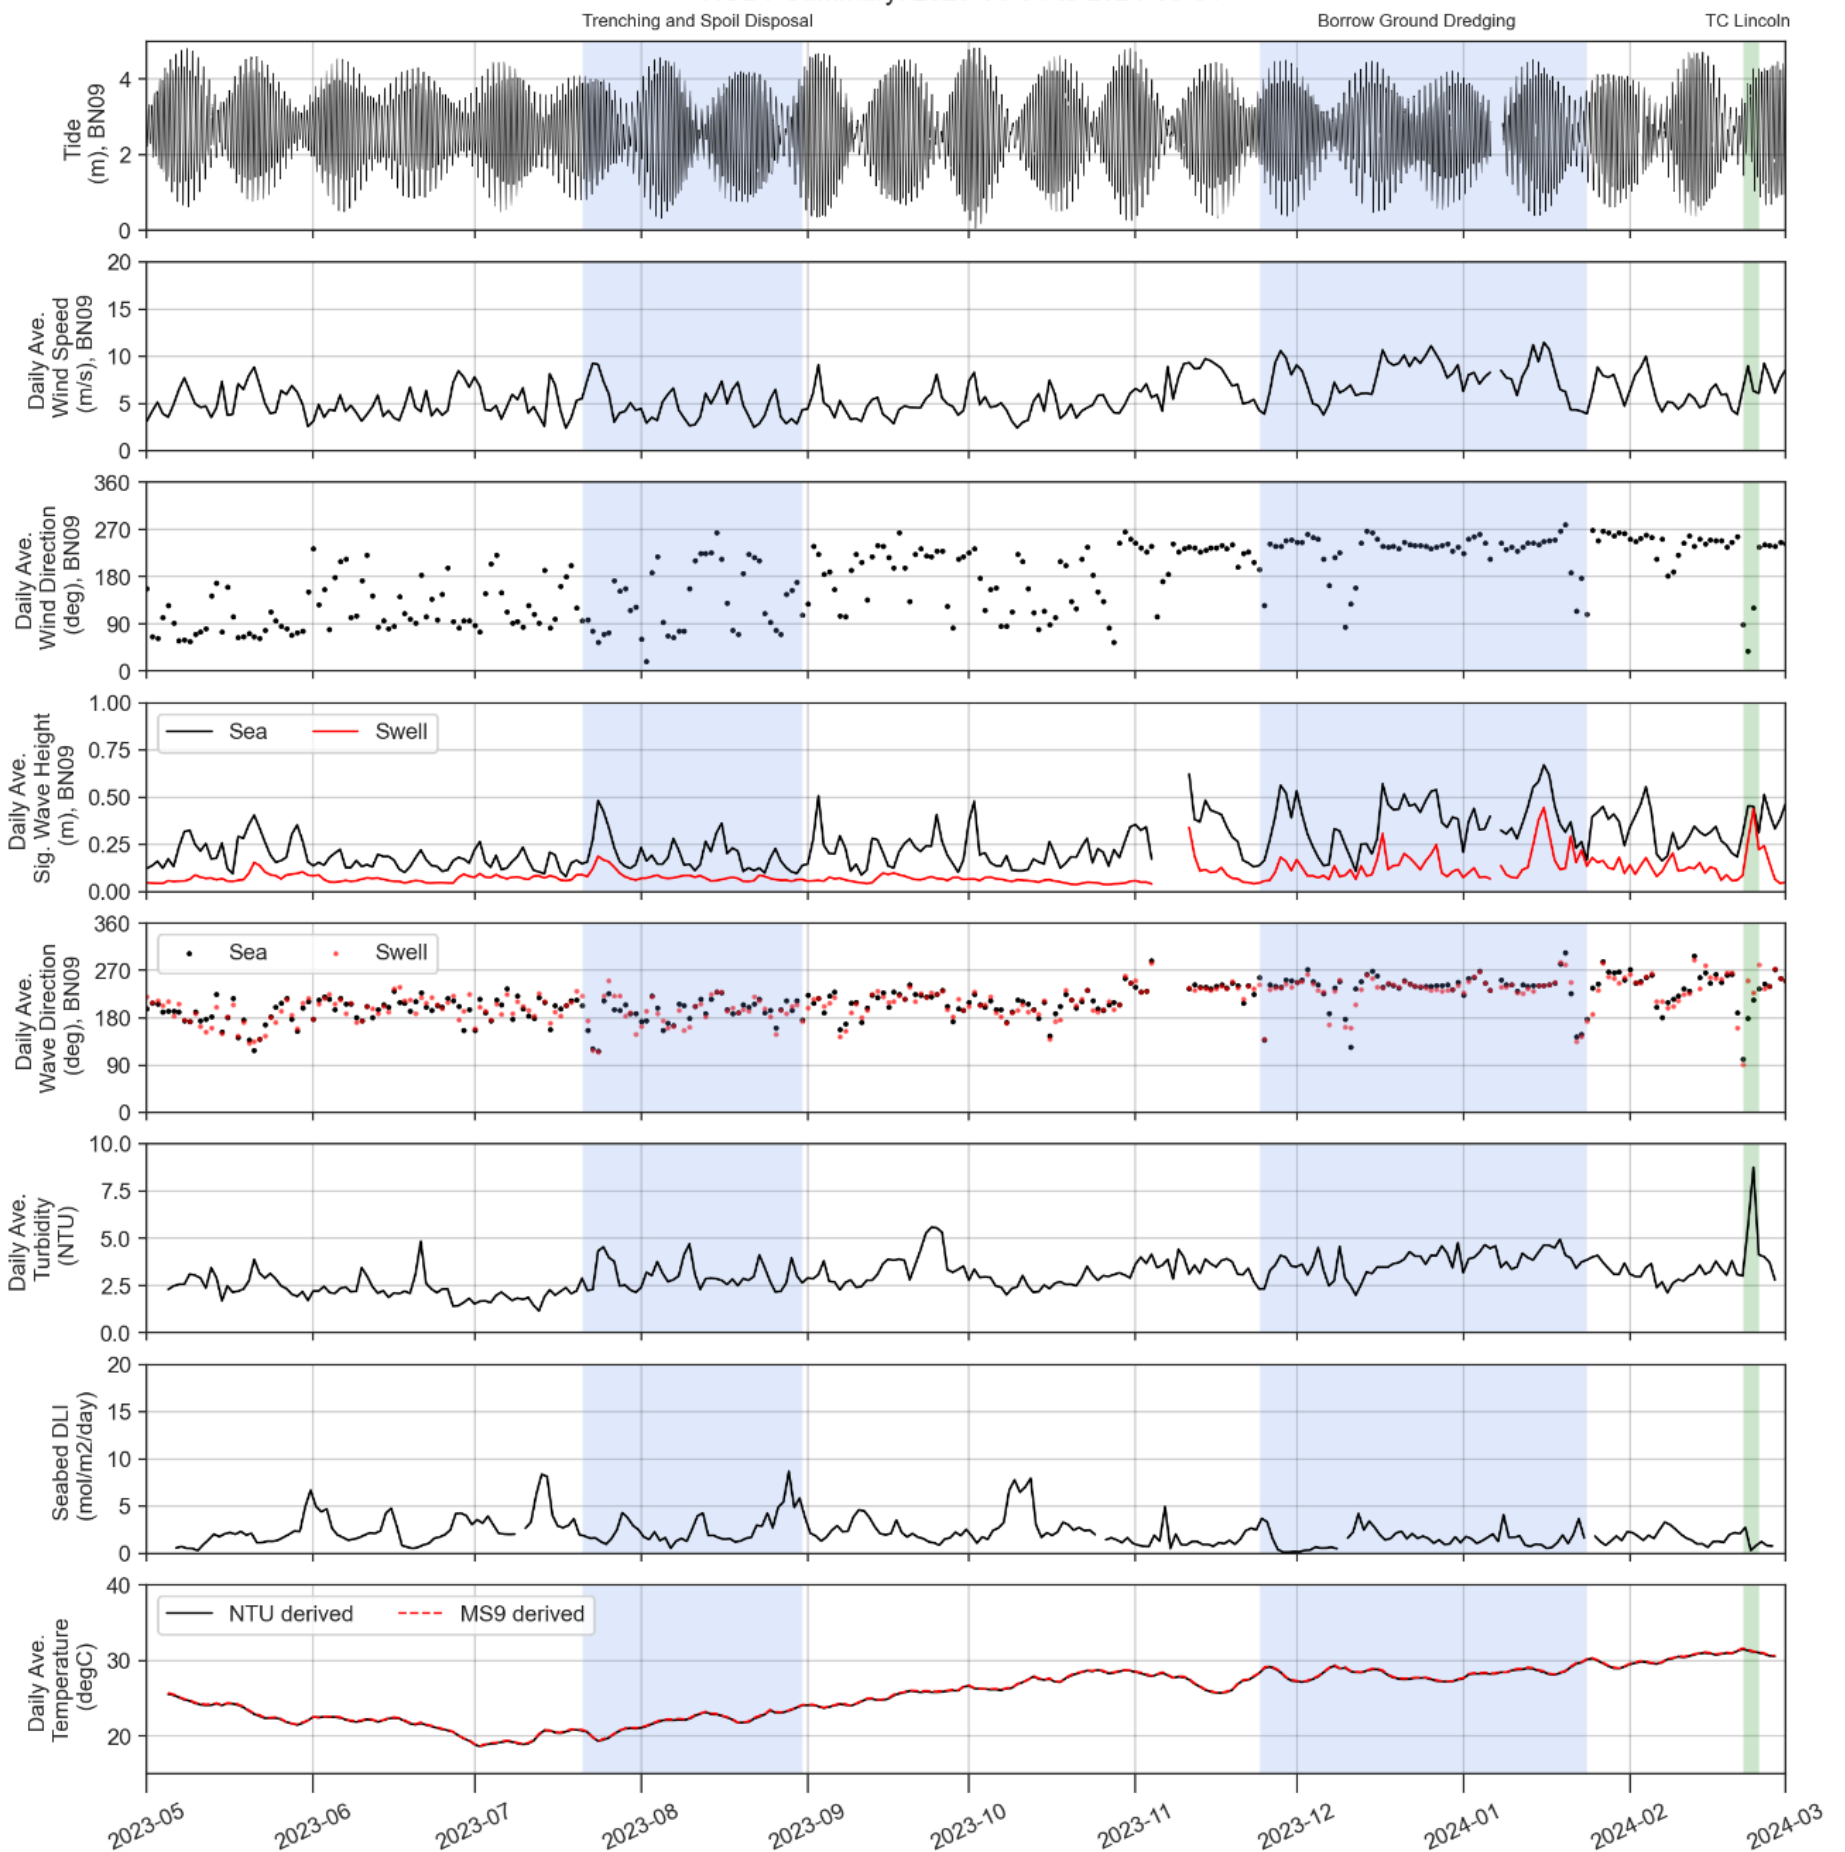
KGBY Summary: 2023-05-01 to 2024-03-01

KGBY is located on the south side of King Bay Supply Base in the Port of Dampier, at a water depth of ~6.7 m LAT. The site is generally protected during easterly conditions in winter, however, is exposed during westerly winds and swell in summer. The sediments are predominantly fine grain sand, silt and clay (WorleyParsons, 2009). Natural turbidity at the site can be exacerbated by tidal flushing through King Bay, daily vessel traffic via berthing activities, propellor wash and movement in shipping channels, and surface run off or airborne dust from the adjacent iron ore facility (Woodside, 2006; WorleyParsons, 2009).

Slightly stronger wind and wave conditions from the west were experienced in the summer months that generally resulted in lower seabed DLI (ranging from 0.2–4.9 mol/m²/day) and slightly higher daily average turbidity (1.9–8.7 NTU) compared to winter (DLI: 1.2–8.7 mol/m²/day, turbidity: 1.2–5.6 NTU), which is likely due to its position in Mermaid Sound. Further, a short-term peak in turbidity (8.7 NTU) and drop in seabed DLI (0.4 mol/m²/day) was apparent during the passing of tropical cyclone Lincoln, which brought easterly winds and waves. At the start of the monitoring program (May 2023), daily average water temperatures were approximately 26°C and gradually decreased with time to approximately 18°C in August 2023 before gradually increasing in the summer months, reaching a maximum of 32°C in late-February 2024.

Figure 13: KGBY site summary

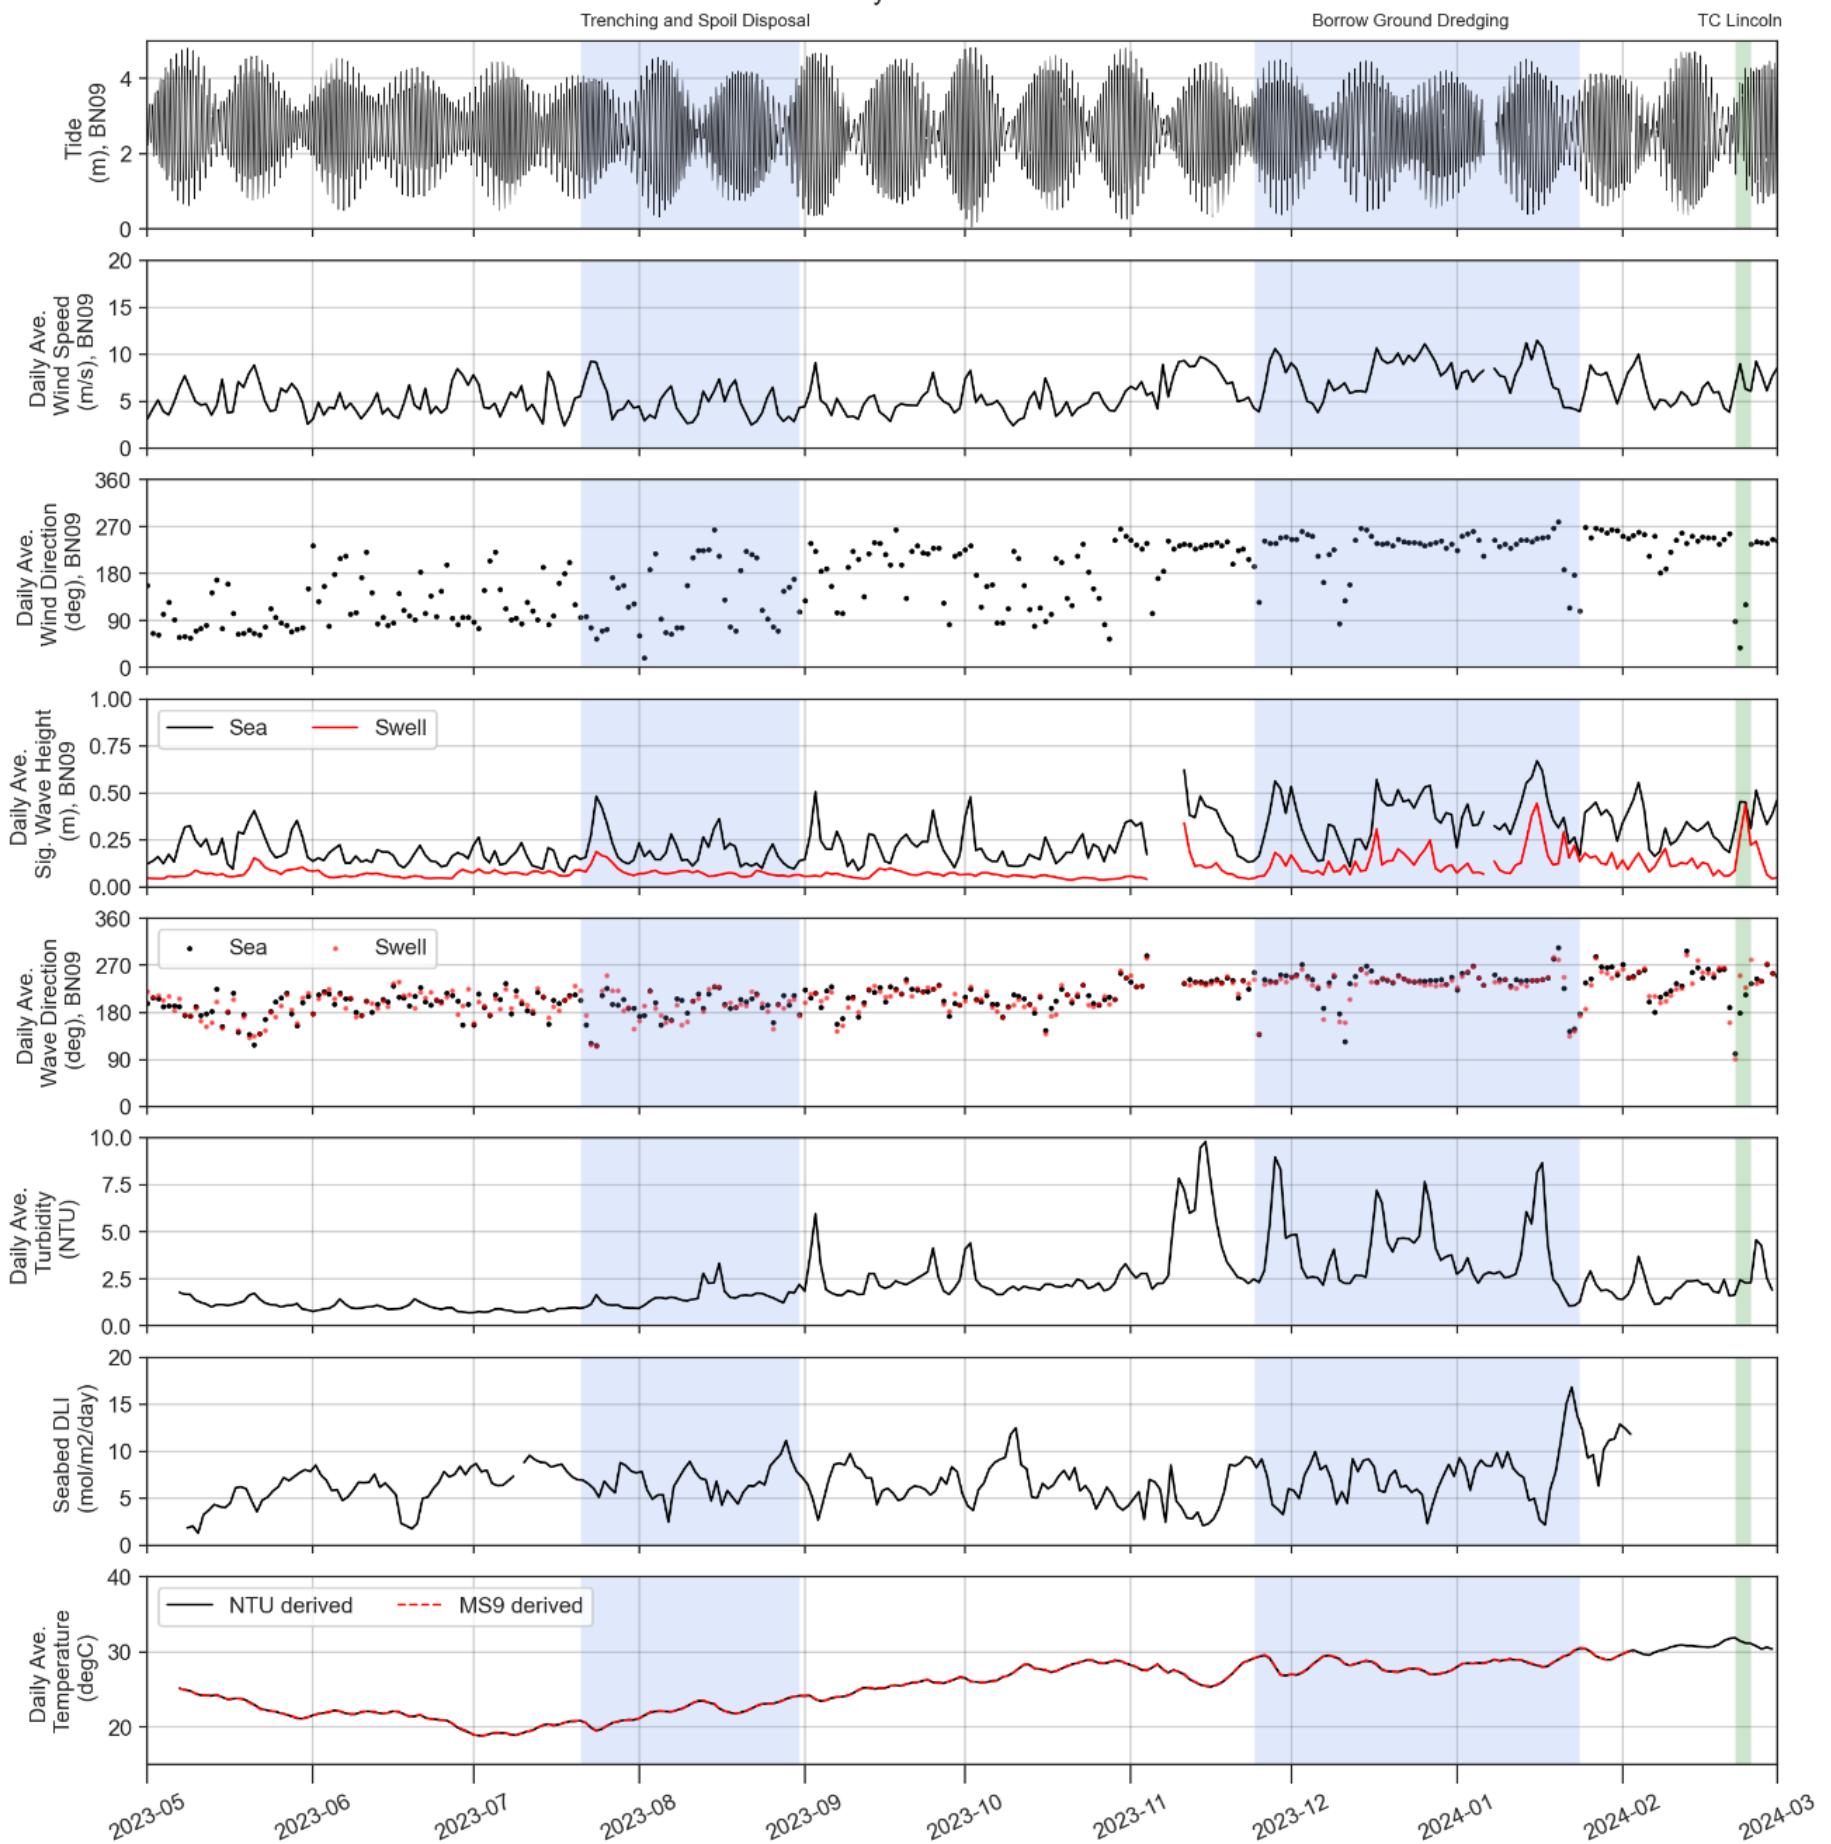
MIDI Summary: 2023-05-01 to 2024-03-01

MIDI is the shallowest monitoring site (2.5 m LAT) in Zone A. The site is located on the northern side of West Mid Intercourse Island adjacent to sandy shorelines and is sheltered by surrounding islands and infrastructure. MIDI is generally exposed only during westerly winds and easterly wave conditions. Water movement through the site and surrounding islands is influenced by bridges and causeways connecting East Intercourse Island and East Mid Intercourse Island to mainland and utilised for Rio Tinto iron ore and Dampier Salt export facilities, respectively.

Seabed DLI was relatively consistent throughout the year, ranging from 1.0 to 16.8 mol/m²/day. The daily average turbidity (ranging from 0.5–5.6 NTU) was relatively lower in the winter months between May and November 2023, whereas peaks in turbidity (up to 9.5 NTU) and associated drops in DLI were observed in summer between November 2023 and February 2024. The relatively higher turbidity in summer compared to winter are likely a result of stronger prevailing west-south-westerly winds and increased significant wave height. Daily average water temperatures at MIDI were identical to site KGBY, with temperatures reaching a minimum of 18°C in August 2023 and gradually increased in the summer months, reaching a maximum of 32°C in late-February 2024.

Figure 14: MIDI site summary

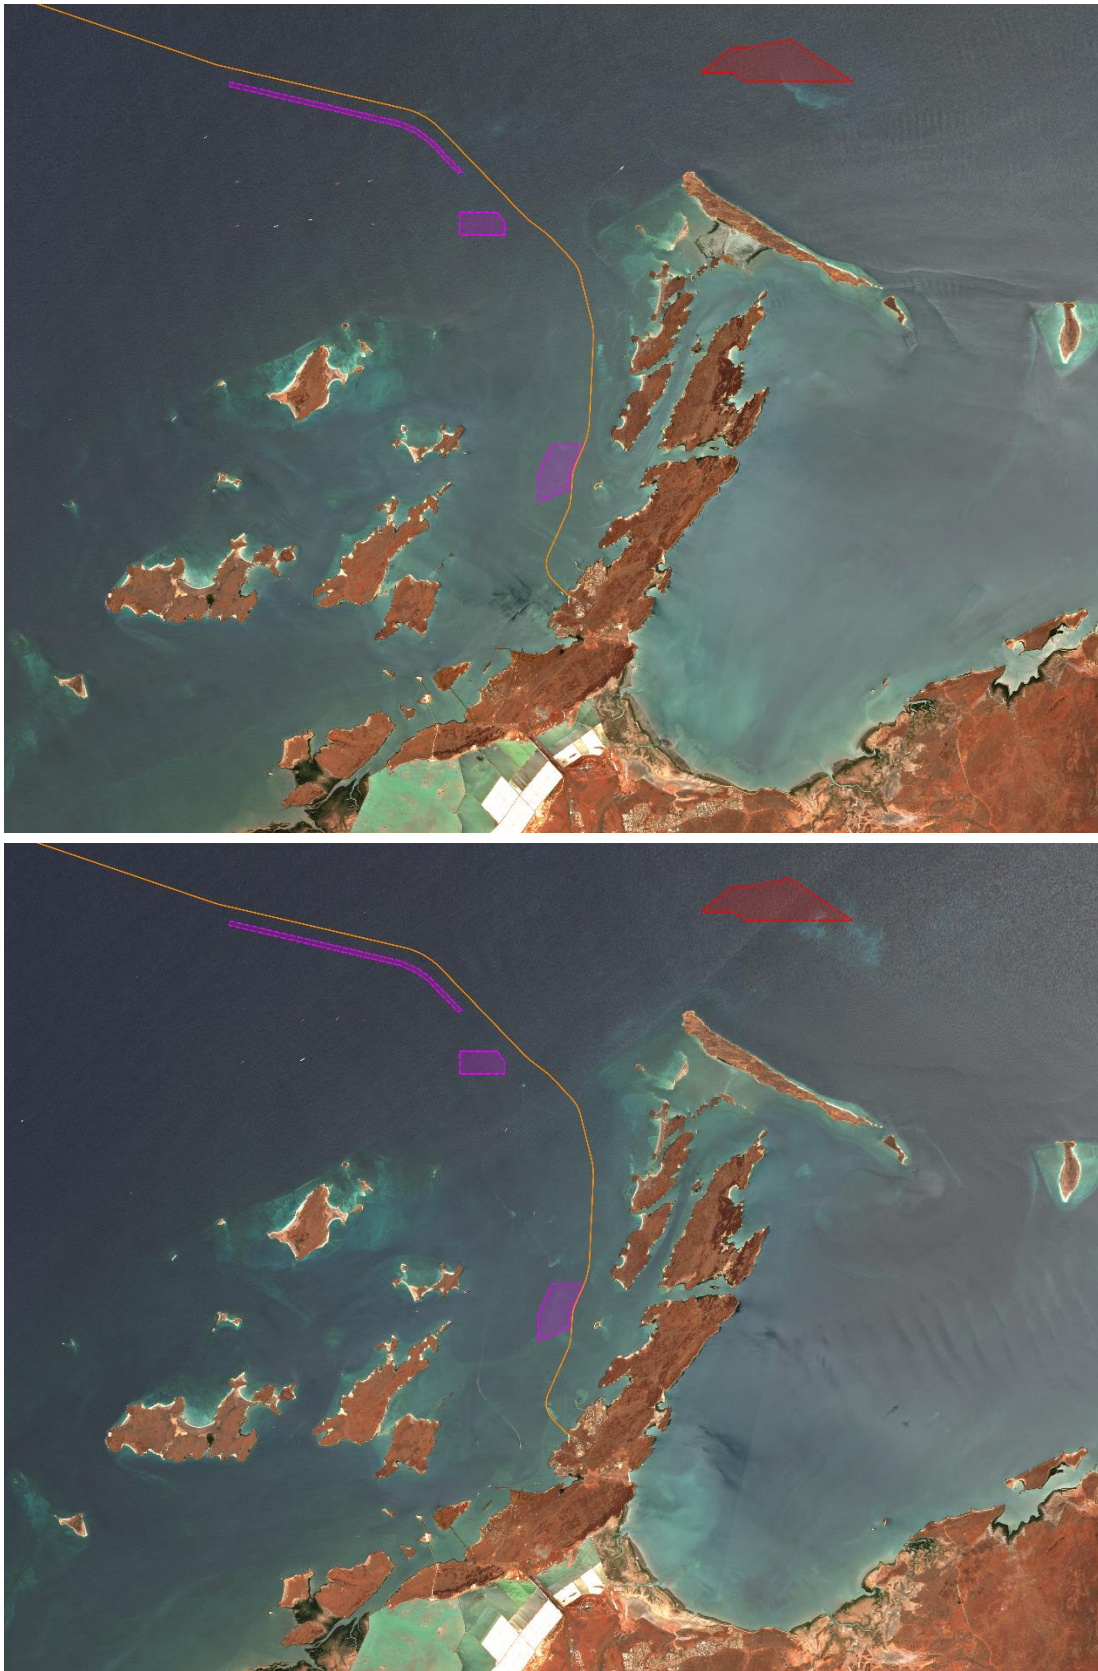
Figure 33: Satellite imagery captured from Sentinel-2 at 10:32 (local time) on 30 December 2023 (top image) and 9 January 2024 (bottom image), with visible plumes during borrow ground dredging. Trunkline is shown in orange, spoil grounds in purple and borrow ground in red

During offshore borrow ground dredging and backfill activities (24 December 2023 and 25 January 2024), surface plumes were visible near the borrow ground and stretching east-west as it was dopped out of suspension along the prevailing current (e.g., Figure 33). Plumes generated from these activities appeared white in colour (Figure 33) compared to the natural turbidity experienced in the region (particularly between Angel and Dolphin Islands and Legendre Island, and Nickol Bay) that appeared as yellow/light brown.

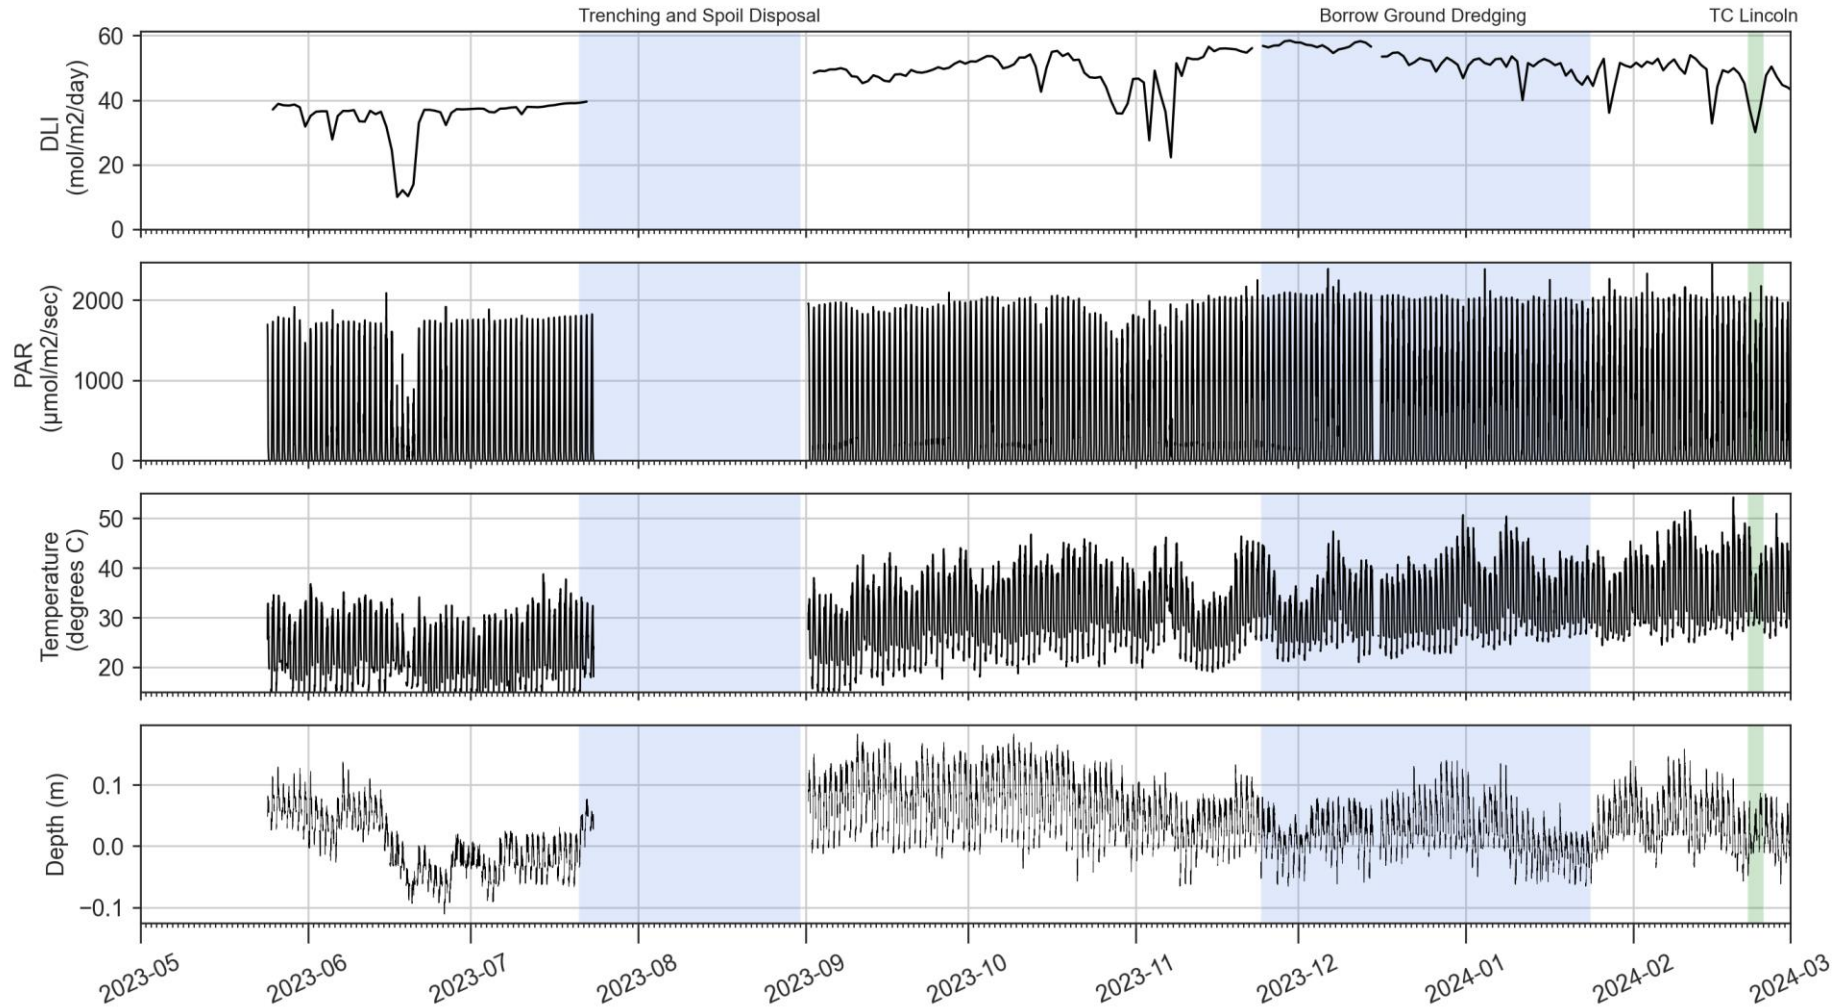
IMO-MS9 Derived Parameters at AMBIENT: 2023-05-01 to 2024-02-29

The terrestrial light logger recorded seasonal trends in ambient light and air temperature. Slightly lower DLI (mean: 42 mol/m²/day) and cooler temperatures (27°C) were recorded during winter compared to summer (52 mol/m²/day and 33°C, respectively). Drops in ambient light and air temperature were caused by cloud cover and low-pressure systems. The logger malfunctioned during trenching and spoil disposal activities and all data during this period did not pass QC assessment. QC'd data collected for ambient light and air temperature are presented in Appendix C.

Figure C.37: Quality controlled light parameters at land-based logger
